## Connections between a replaceable coupling beam and a double skin composite shear wall exhibit seismic activity

To maximise the effectiveness of the hybrid coupled wall system, a special connection between replacement coupling beams (RCB) and double skin composite shear walls (DSCSWs) is designed. For structural safety, the RCB-to-DSCSW link's seismic design is essential. This research examines the seismic behaviour of RCB-to-DSCSW couplings. Reversed cyclic stress was applied to two specimens with varied embedded rebar arrangement schemes and one specimen with an embedded steel I-beam. All of the specimens failed in the same manner, primarily as a result of concrete crushing at both ends of the joint, weld tensile fracture, and localised buckling of the steel faceplate. The strength and ductility of connections were significantly impacted by concrete crushing and weld tensile fracture. The concrete was swiftly crushed and the connection specimens reached their maximum load capacity at the current or next stage of weld tensile fracture. Compared to RC constructions, all of the specimens showed lower ductility coefficients. Additionally, these two varieties of embedded rebar con

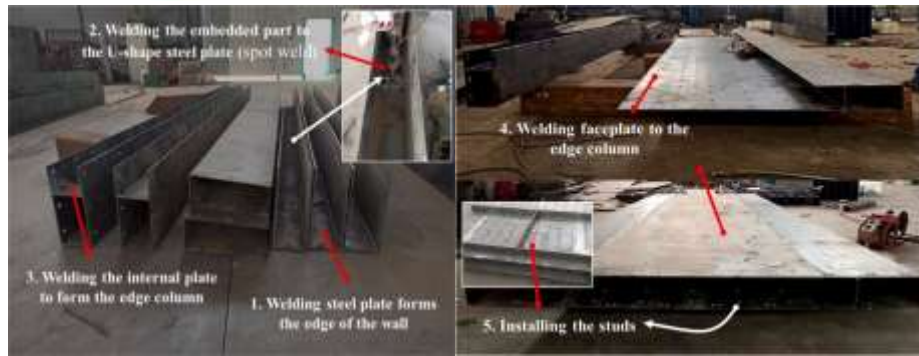
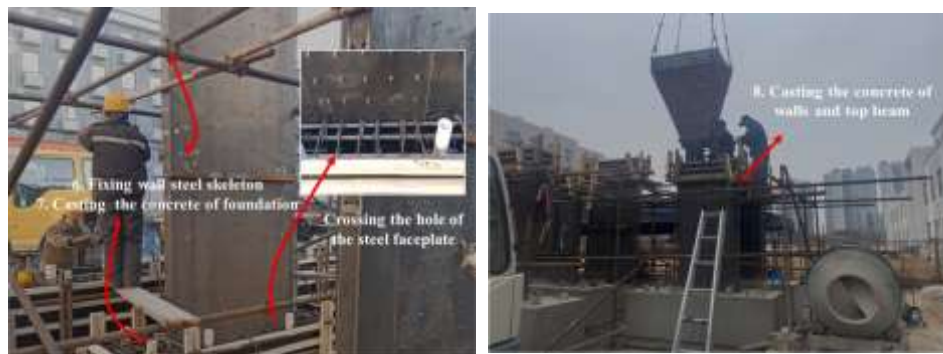
(a) Fabrication of edge column

(b) Fabrication of wall steel skeleton

(c) Fixing wall skeleton and casting concrete of foundation

(d) Casting concrete of wall and top beam

**Fig. 2.** Fabrication process of the Specimens.

Step 1: Form the edge of the wall with a welding steel plate (U-shape plate), Welding the embedded section to the U-shaped plate is the second step.

Step 3: Weld the interior steel plate to the U-shape plate to create an edge column.

Step 4: Weld the two connecting edge column faceplates.

Step 5: Attach the studs.

Step 6: Fixing the steel skeleton of the wall.

Step 7: Pouring the foundation concrete.

Step 8: Pouring the concrete for the top loading beam and the wall.

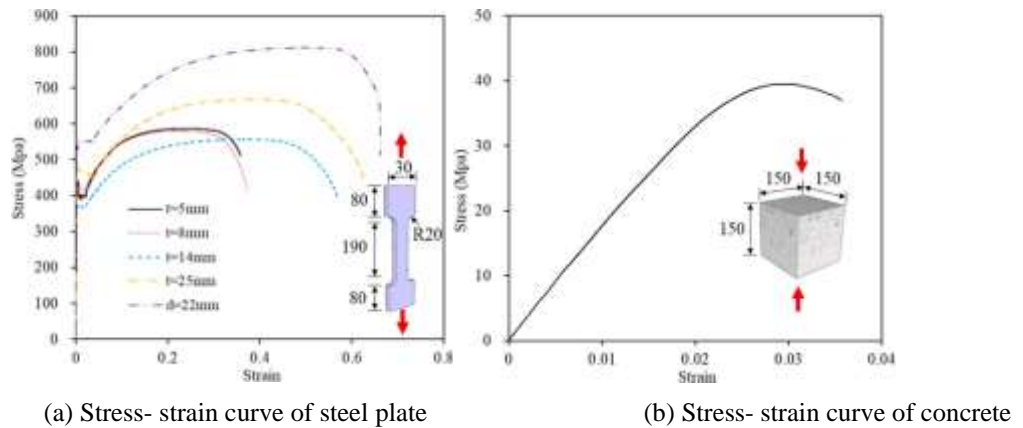
**Fig. 4.** Material test of steel plate and concrete

Three 150×150×150 mm<sup>3</sup> cubes are manufactured for compression testing during the concrete casting process in order to determine their 28-day compressive strength. These cubes' average compressive strength ( $f_{cu}$ ) is 42 MPa, with a standard variation of 4.97 MPa.

The mild steel Fe 250 is used to make specimen steel plates. Fe 415 steel is used to make the rebars in sample CJ-1, CJ-2, and CJ-3. Table 1 displays their mechanical qualities
