Experimental Investigation of Insulator Dielectric Strength of Transmission Tower in Rocky Areas

Abstrac

Keywords: Back-flashover, Insulator contaminant, Rocky Areas.

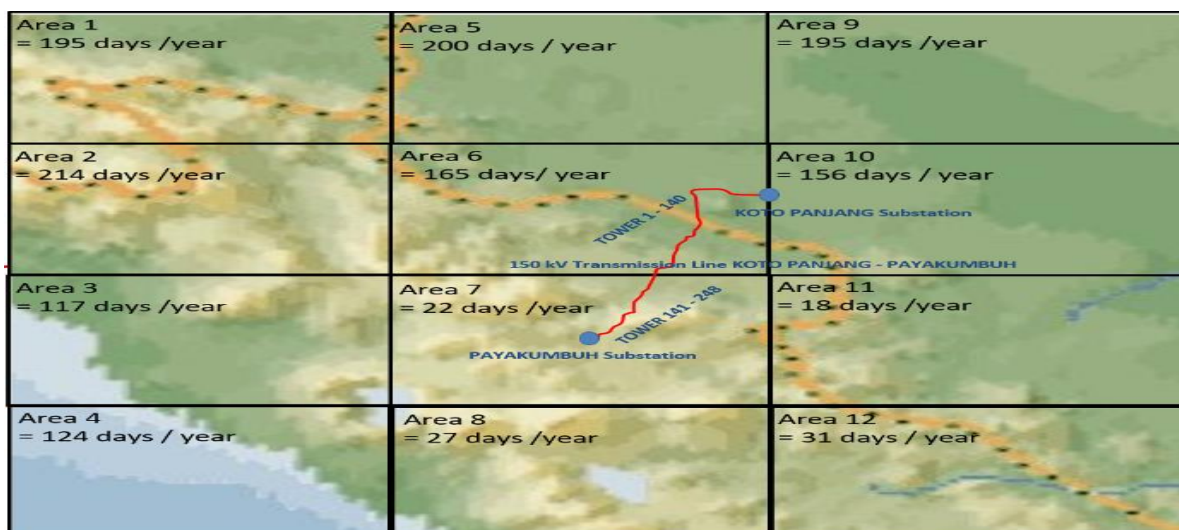
Figure 1 suggests Western Sumatera's isokeraunic level map. Between Payakumbuh and Koto Panjang, there is a certified pink overhead line of 150 kV. 51 (20.5%) of the 248 pagodas are in rice fields, 41 (16.5%) are in deserts or grasslands, and 156 (63%) are on hills. There have been 165 days with thunderstorms, with high temperatures ranging from 33°C to 36°C. consistent with 12 months within the place in which towers No. 1 to 140 stand (Warmi and Michishita, 2017) (Warmi and Michishita, 2018) (Warmi and Viyoldi, 2019) (Warmi and Michishita, 2017). Every year, Indonesia's level of entertainment generally rises rapidly due to the country's tropical climate. The topography of the path also has a significant impact on the variety of lightning strikes.

Figure 1. Map of Isokeraunic level

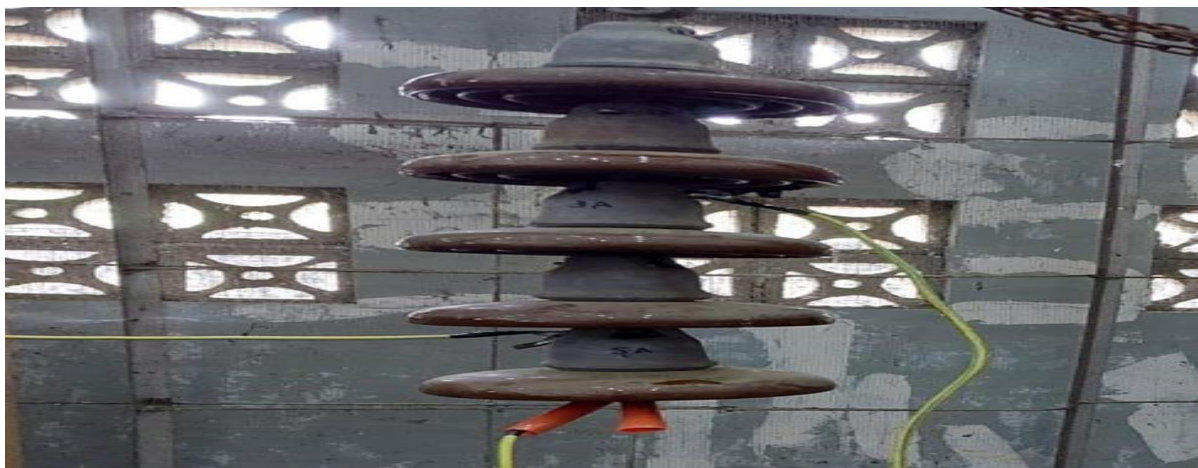
Figure 5. Testing the Breakdown Voltage of the Mossy Insulator

The test shown in Figure 5 is an insulator test which is carried out in stages from the first plate to the third plate using the same voltage test on each plate of 78.82 kV. Meanwhile, the results of the next insulator plates are done by analyzing the trend values of the three plates that have been tested. The results can be seen in Table II below.

The insulator used for testing the breakdown voltage was the insulator with moss contaminant has covered its surface. This mossy-contaminated insulator has been used for about 2-5 years. In addition, when testing the insulators the number did not match to the experimental circuit in Figure (a). This happened because of the equipment capacity to perform was insufficient; for instances, the transformer was not able to increase the voltage of 150 kV for one string of insulators, the cables were not sufficient with the intended use, and limitation of the oscilloscope in testing the voltage value. As a results, the tests was carried out only by using three insulating plates equipped by five insulator chains as shown in Figure 4 below (Warmi and Viyoldi, 2019) (Ouyang *et al.*, 2019) (Warmi and Febrian, 2021)..

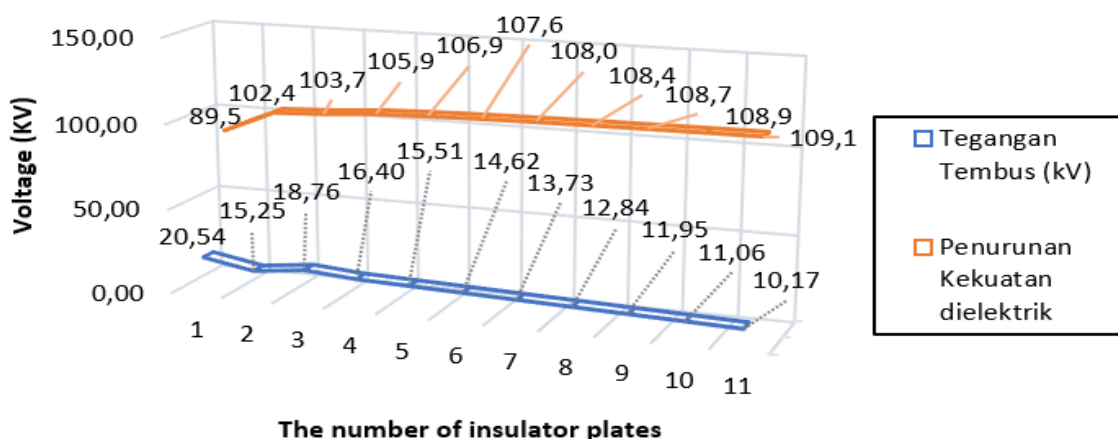
Figure 6. *The Breakdown Voltage Test of the Mossy Insulator.*

Figure (f) shown the number of insulator plates tested affects the breakdown voltage value and the dielectric strength value of the insulator. The more mossy insulator the tested, the higher the breakdown voltage value that occurs. Similarly, the low electric strength is caused by the BIL value of a insulator of 110 kV. The decrease in the value of dielectric strength that occurs is 25.03% per insulator.

Based on table II above, a graph of the comparison of the value of the breakdown voltage measurement with a decrease in the dielectric strength of the insulator can be drawn as in figure (c). The breakdown voltage test can only be carried out using 3 insulator plates, while the next insulator plate test is shown in Figure 5 below.
